Stonhard offered lining solutions in containment areas and traffic aisles to withstand specific chemical exposures and traffic conditions

Products used at Embraer Portugal S.A.:
 Stonchem® 602 • Stonchem® 678 • Stonchem® 778 •
 Stonchem® 878

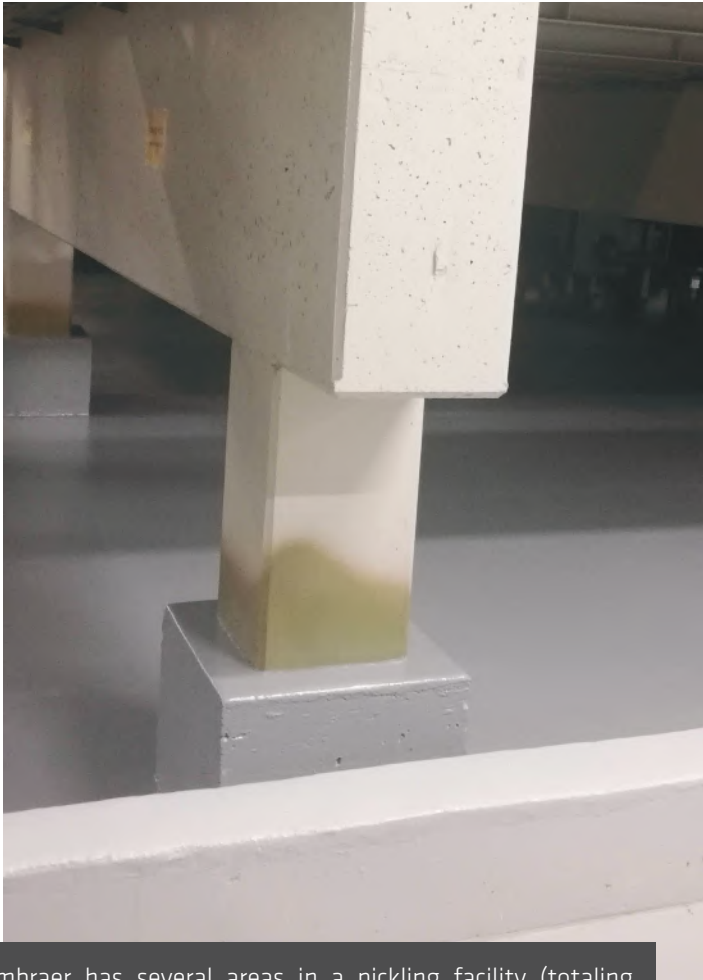
The existing containment area had been coated with a polyurea in 2012 that showed swelling, wrinkling, and delamination- all indicators of severe chemical attack. The chemicals in question included 98% sulfuric acid, 68% nitric acid, and 50% sodium hydroxide. The customer also had heavy forklift traffic in some areas.

With the support of the technical department multiple Stonchem lining systems were selected based on the area, including Stonchem 602, 678, 778, and 878. These Stonchem systems range from high-build novolac epoxy (600 series) to mortar-based, fiberglass-reinforced Polyester (700 series) and Vinyl Ester (800 series) resin chemistries, each suitable for specific chemical exposure parameters. All lining systems were applied only after full removal of the existing lining system to ensure correct adhesion to the concrete substrate.

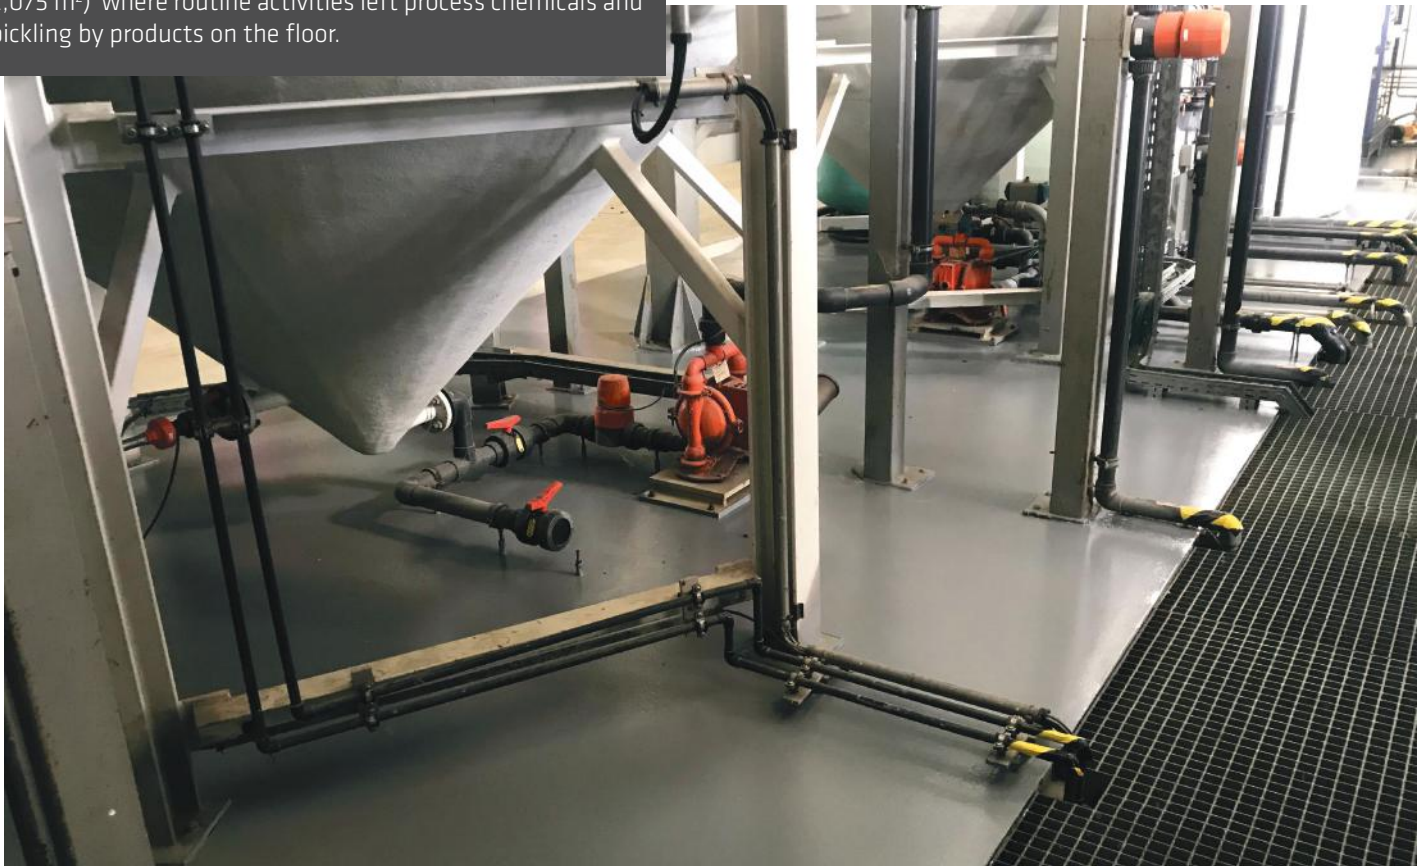
Embraer has several areas in a pickling facility (totaling 2,075 m²) where routine activities left process chemicals and pickling by products on the floor.
